# Medical Devices: The Therac-25\*

Nancy Leveson  
University of Washington

## 1 Introduction

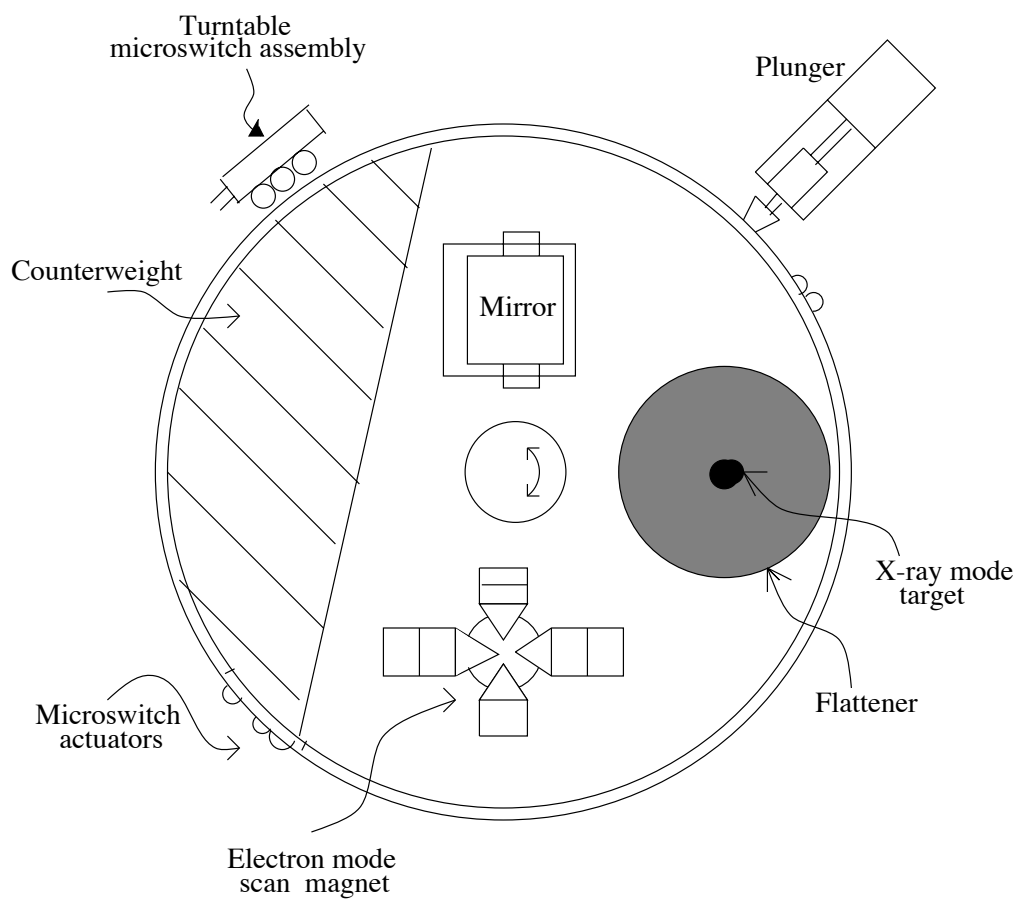
Figure 1: Upper turntable assembly.

**Turntable Positioning.** The Therac-25 turntable design plays an important role in the accidents. The upper turntable (see Figure 1) rotates accessory equipment into the beam path to produce two therapeutic modes: electron mode and photon mode. A third position (called the field light position) involves no beam at all, but rather is used to facilitate correct positioning of the patient. Because the accessories appropriate to each mode

are physically attached to the turntable, proper operation of the Therac-25 is heavily dependent on the turntable position, which is monitored by three microswitches.

The computer senses and controls turntable position by reading a 3-bit signal about the status of three microswitches in the turntable switch assembly. Essentially, AECL determined that a 1-bit error in the microswitch codes (which could be caused by a single open-circuit fault on the switch lines) could produce an ambiguous position message to the computer. The problem was exacerbated by the design of the mechanism that extends a plunger to lock the turntable when it is in one of the three cardinal positions: The plunger could be extended when the turntable was way out of position, thus giving a second false position indication. AECL devised a method to indicate turntable position that tolerated a 1-bit error so that the code would still unambiguously reveal correct position with any one microswitch failure.

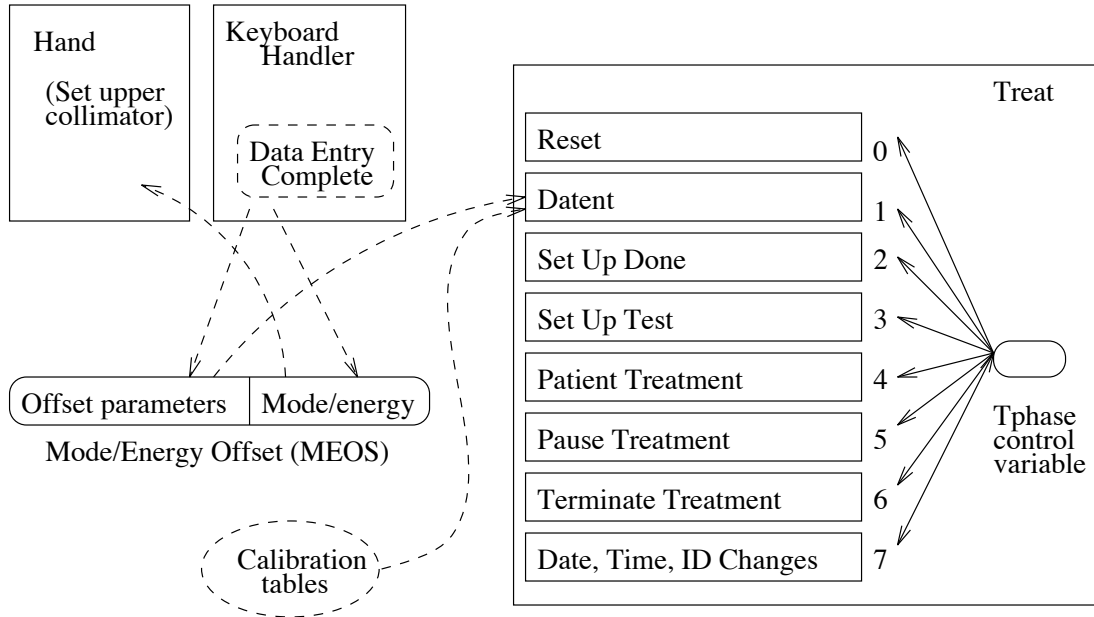
Figure 3: Tasks and subroutines in the code blamed for the Tyler accidents.

The treatment monitor task (Treat) controls the various phases of treatment by executing its eight subroutines. The treatment phase indicator variable (Tphase) is used to determine which subroutine should be executed (Figure 3). Following the execution of a particular subroutine, Treat reschedules itself.

But this is not the only problem. Upon exit from the Magnet subroutine, the data entry subroutine (Datent) checks the Data Entry Complete variable. If it indicates that data entry is complete, Datent sets Tphase to 3 and Datent is not entered again. If it is not set, Datent leaves Tphase unchanged, which means it will eventually be rescheduled. But the Data Entry Complete variable only indicates that the cursor has been down to the command line, not that it is still there. A potential race condition is set up. To fix this, AECL introduced another shared variable controlled by the keyboard handler task that indicates the cursor is not positioned on the command line. If this variable is set, then prescription entry is still in progress and the value of Tphase is left unchanged.

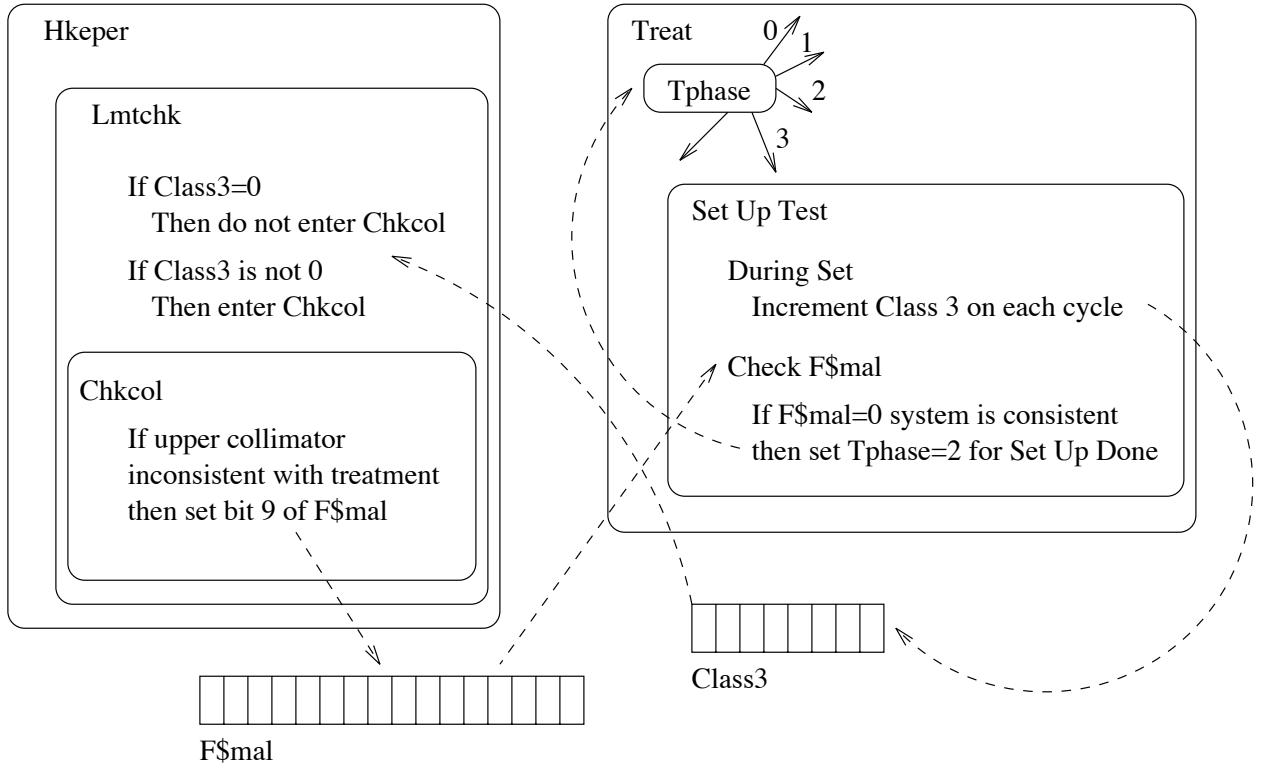
Figure 4: The Yakima software flaw.

The second Yakima accident was again attributed to a type of race condition in the software — this one allowed the device to be activated in an error setting (a “failure” of a software interlock). The Tyler accidents were related to problems in the data-entry routines that allowed the code to proceed to Set Up Test before the full prescription had been entered and acted upon. The Yakima accident involved problems encountered later in the logic after the treatment monitor Treat reaches Set Up Test.

The Therac-25’s field light feature allows very precise positioning of the patient for treatment. The operator can control the machine right at the treatment site using a small hand control that offers certain limited functions for patient setup, including setting gantry, collimator, and table motions.

The overexposure occurred when the operator hit the “set” button at the precise moment that Class3 rolled over to zero. Thus, Chkcol was not executed and F\$mal was not set to indicate that the upper collimator was still in the field-light position. The software turned on the full 25 MeV without the target in place and without scanning. A highly concentrated electron beam resulted, which was scattered and deflected by the stainless
